County: PIKE

Certified Land Corner Restoration Perpetuation and Filing Record
Division of Land Surveys, Little Rock, AR 501-683-1666

S: 36 T: 08 S R: 24 W

Corner EAST QUARTER GCDB number 700140 Accuracy (ft) 0.14'
Latitude / Longitude (required) 34°00'29.99736"N, 93°30'28.73378"W
Surveyor KYLE PENNINGTON PS number 1807 Survey Date 12-01-2020
Previous certificate on file? YES If so, list doc # 005526 Horz Datum NAD83(2011)
Position determined by TRIMBLE R12 GPS RTK CONTROL OBSERVATION ADJUSTED TO LOCAL POINT PROCESSED THROUGH 3-HOUR NGS OPUS OBSERVATION.

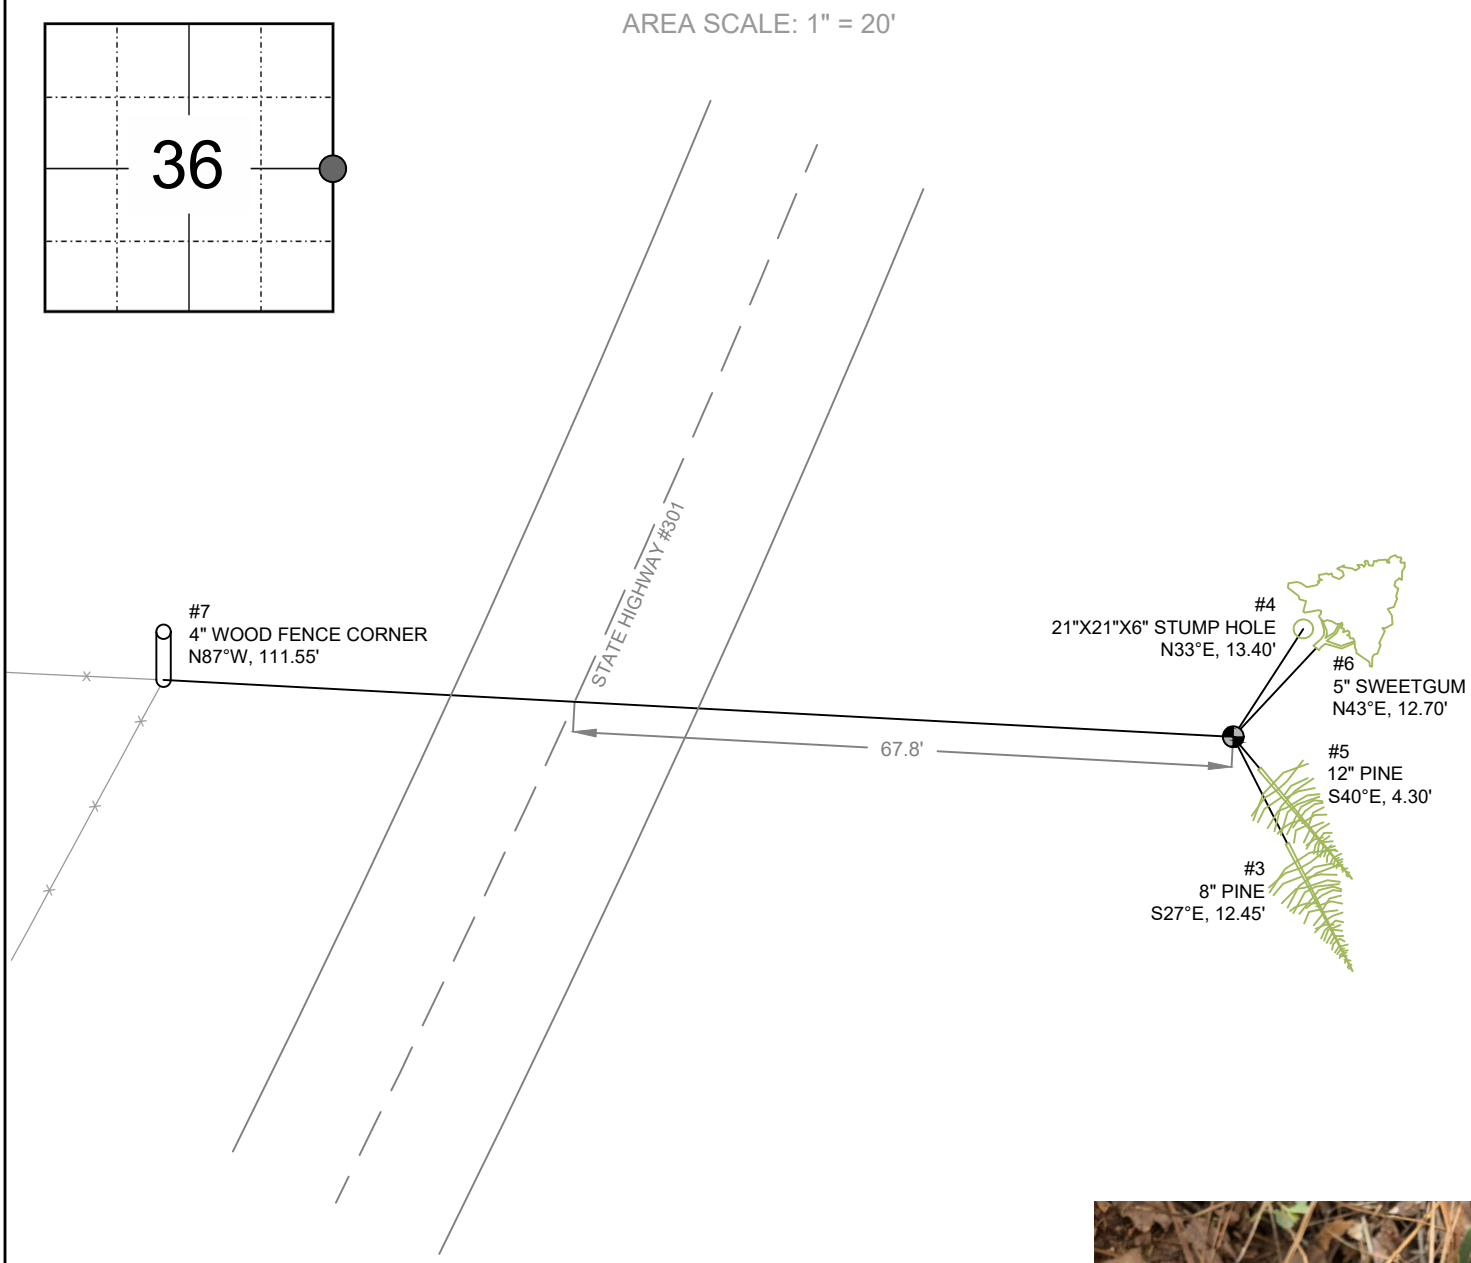
On June 05, 2020, I find Mr. DeAryan's AGC monument in good condition projecting 4 inches, being 1.0 foot west of a witness sign on steel post. From said monument is:

1. No Evidence
2. Stump hole (15"x15"x5"): S85°E, 17.65' (questionable)
3. 8" Pine: S27°E, 12.45'
4. Stump hole (21"x21"x6"): N33°E, 13.40'
5. 12: Pine: S40°E, 4.30'

Accepted Mr. DeAryan's monument from 1982 as located based on existence of monument, #3 and #5, and evidence of #4 and on December 01, 2020 I re-fresh markings on #3 and #5 take the following:
6. 5" Sweet Gum: N43°E, 12.70'
7. 4" Wood Fence Corner Post: N87°W, 111.55' (across Highway #195)
   Center of Highway #195, through a curve, is approximately 67.8' west of corner in-line with #7.

#3, #5, and #6, each marked with Bearing Tree tag and the following: orange belt at 5 feet, scribed "WT" at base facing monument, and 60-D Mag-Hub nail in side perpendicular to monument. #7 marked with Location Tag and orange belt.
